Advanced Development Receiver Thermal Vacuum Tests With Cold Wall

Final Report

Leigh M. Sedgwick The Boeing Company Seattle, WA

June 1991

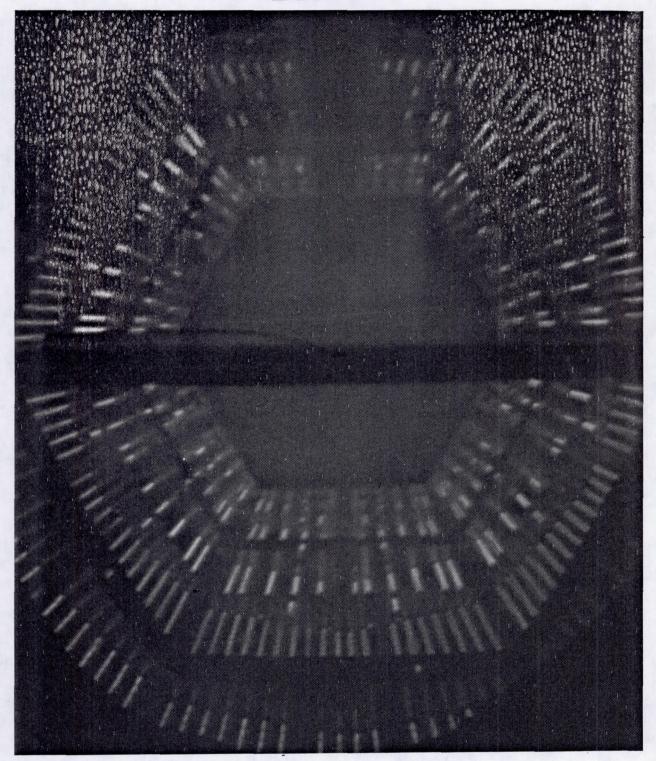
Repair of the electrical power distribution box required about 1.5 hours during which, an estimated 190 lbs or 26 percent of the salt contained in the heat storage tubes may have solidified because of the cavity heat losses. The heater zones were then powered to about 22 kW to slowly remelt the salt. The effect of the off-gassing event associated with the loss of LN_2 to the cold plate and shrouds is visible in the blurred and distorted borescope image shown in Figure 5-7 which was taken after repowering of the heater zones.

Figure 5-6: Boroscope Photograph of the Receiver Cavity Just Prior to Thermal Arrest During VT.2.

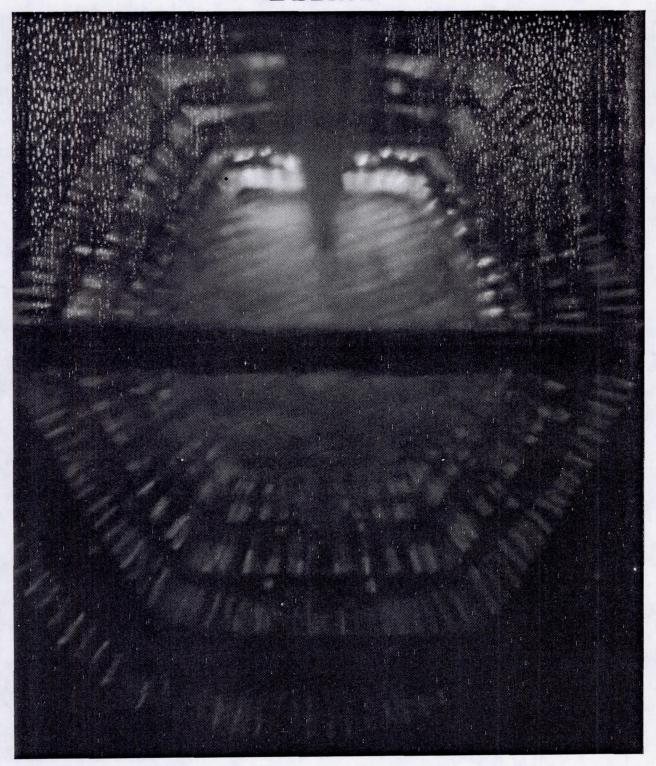
Figure 5-8: Initial Power Up of the Quartz Lamp Heater Zones During VT.3 As Viewed Through the Borescope.

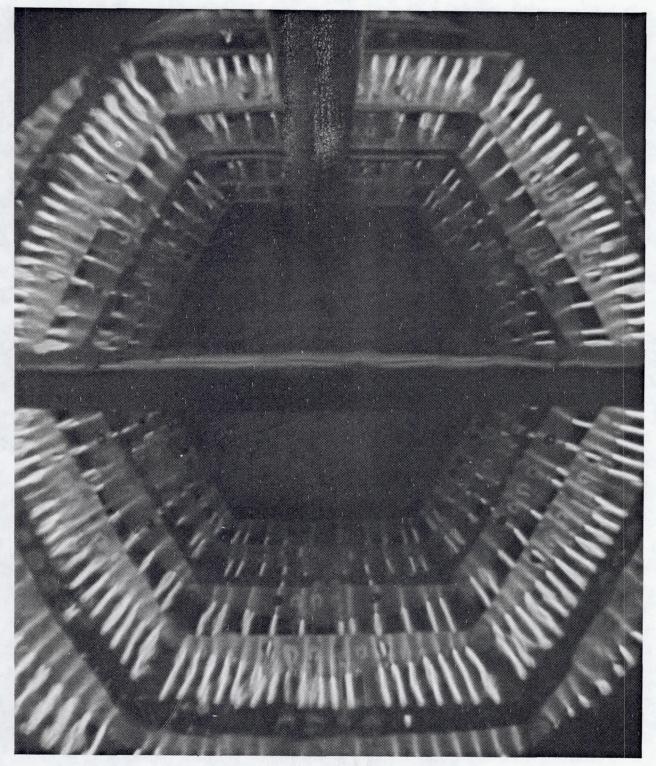
Figure 5-9: Full Power Operation of the Quartz Lamp Heater During Orbit #1 of VT.3.

The electrical power to heater zones E and F was lost during the last few minutes of the 2nd orbit. The problem was caused by a temperature-sensitive circuit breaker on the large power transformer that supplied the SCR's for those zones. Figure 5-13 shows a photograph of the cavity while these 2 zones were off and illustrates the usefulness of the borescope to confirm proper heater operation.

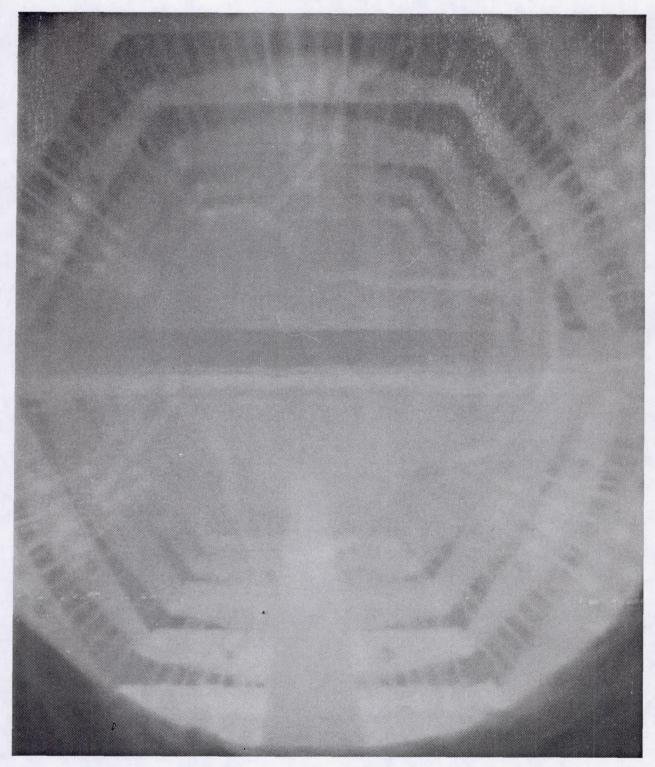
Figure 5-10: Lens Contamination Image Obtained By Focusing on the Front Lens of Borescope.

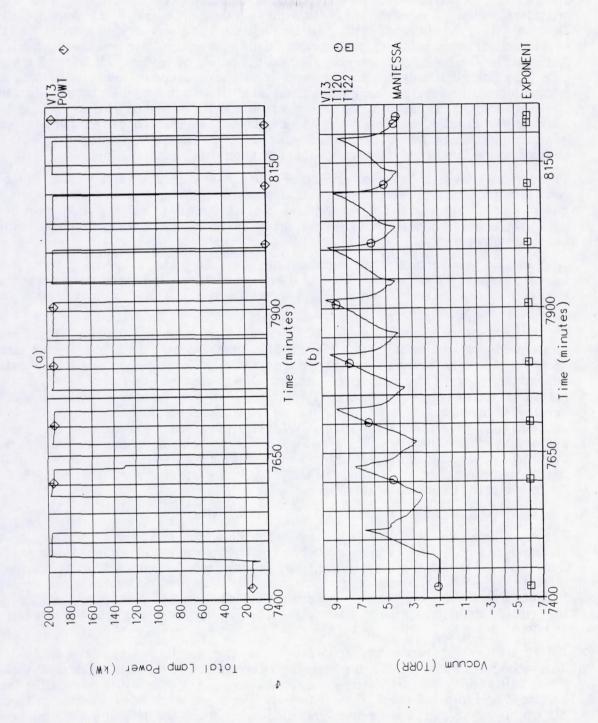
Figure 5-12: (a) Total Quartz Lamp Heater Power During VT.3; and (b) Chamber Vacuum Level During VT.3.

An abrupt change in the chamber vacuum occurred during the 9th orbit that began the final and longest-term vacuum out-gassing event of the test conduct period. Previous to this event (see Figure 5-12), the vacuum level cycled within the 10^{-6} torr range with the orbital cycles. During the event, the vacuum no longer was driven by cavity temperatures and gradually increased up to the 10^{-4} torr range. Test mode VT.5 was continued despite the increase in chamber vacuum to preserve as much of the original test matrix as possible. The higher vacuum increased the risk of a corona arching between the lamp zones and/or to the heat storage tubes and, therefore, test mode VT.5 was terminated with somewhat marginal steady conditions at the end of orbital simulation #12.

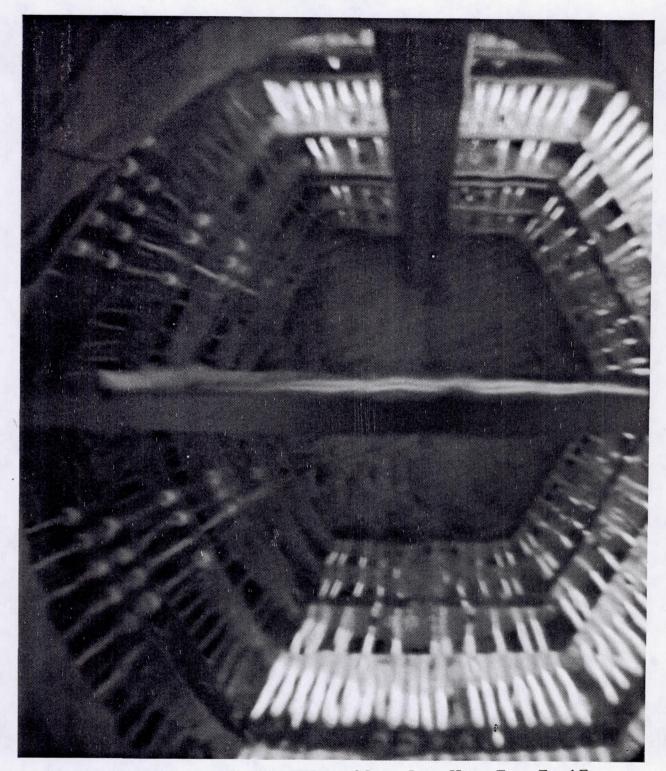
Figure 5-13: Borescope Image Showing the Loss of Quartz Lamp Heater Zones E and F at the End of Orbit #1.

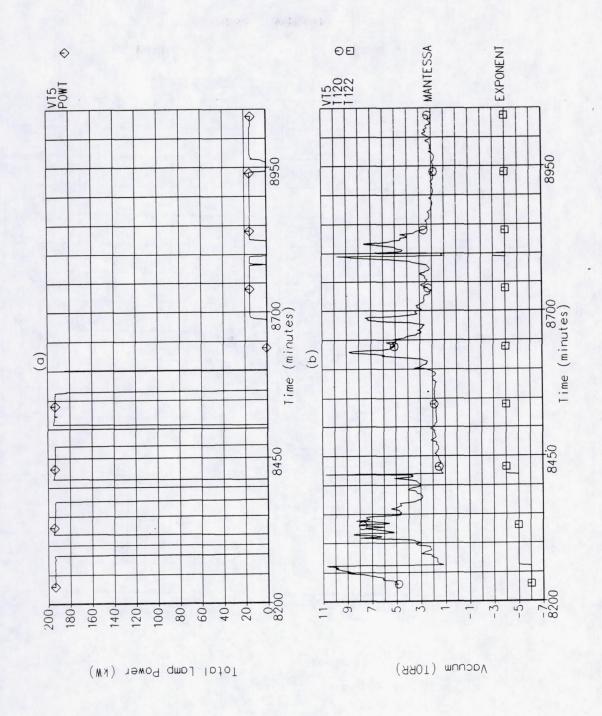
Figure 5-18: (a) Total Quartz Lamp Heater Power During VT.5; and (b) Chamber Vacuum Level During VT.5.

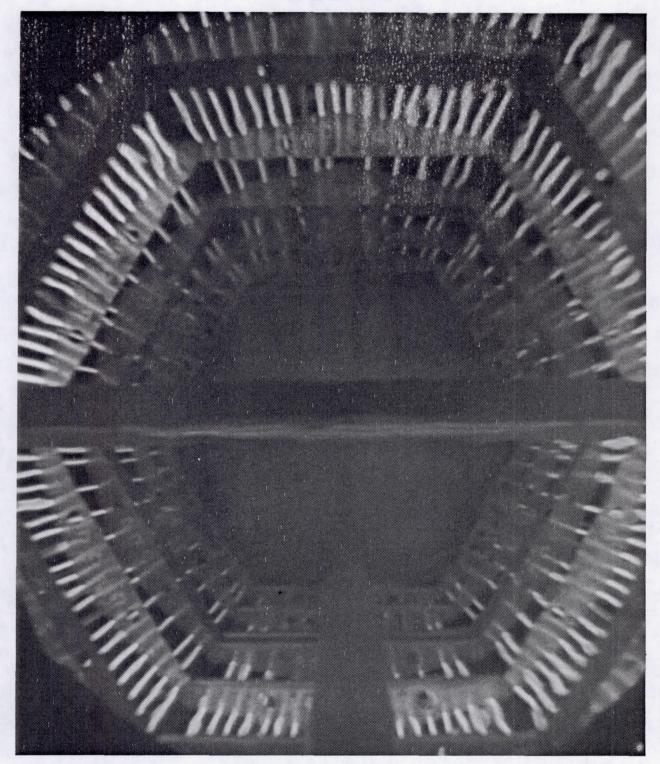
No significant events occurred during the conduct of test mode VT.6. Pictures of the cavity taken through the borescope appeared to be changed very little (and maybe slightly improved) from those of earlier orbits. Figures 5-23 and 5-24 show views of the cavity taken at the end of the sunlit period and beginning of the eclipse period of orbit #17. While not too spectacular in black and white, these photographs show the degree of image clarity that could be seen through the borescope at this point in time with the lamps on and off in the cavity.

Figure 5-23: Cavity Borescope Image Near the End of the Sunlit Period of Orbit #17.

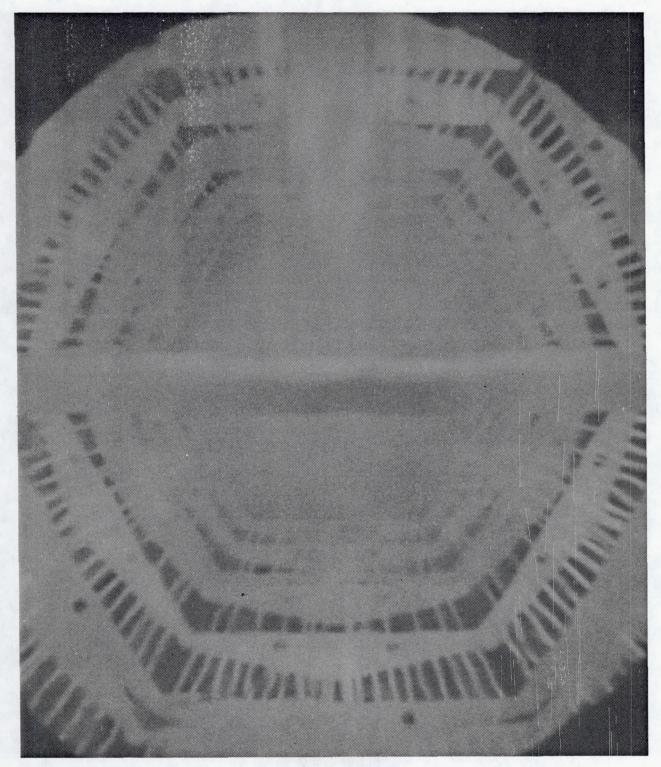
Figure 5-24: Cavity Borescope Image Near the Beginning of the Eclipse Period of Orbit #17.

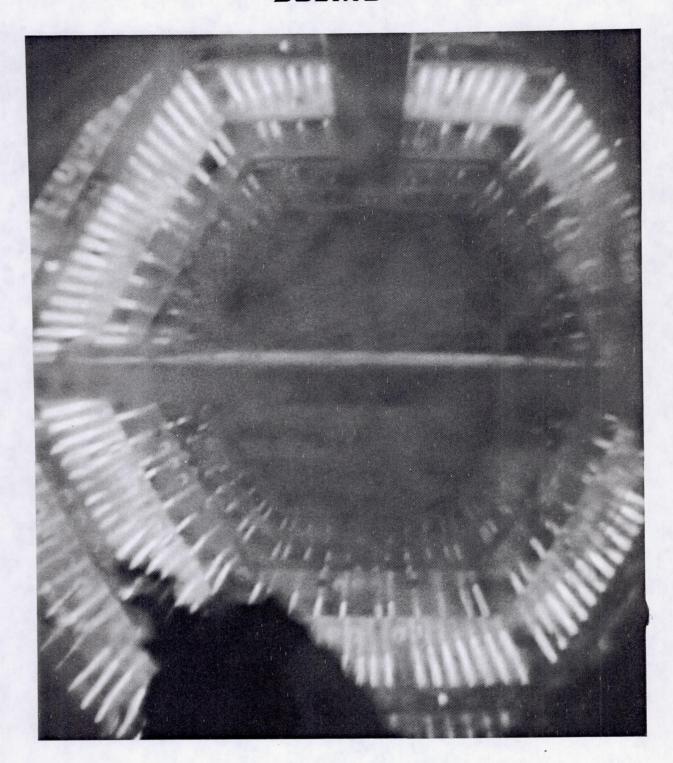
Chamber vacuum levels continued to improve after the end of the last vacuum event, returning to the 10^{-6} torr level and cycled with the heater operation. The image through the borescope began to clear up as shown the Figures 5-38 through 5-40. Figure 5-38 shows the image during the sunlit period of orbit #27. The solid material deposited on the quartz lens began to flake off and about 1/6th of the cavity is visible. It is interesting to note the similarity in the lines of the contaminated regions shown in this figure and that shown previously in Figure 5-10. Figure 5-39 shows about 1/4th of the cavity image is visible 2 orbits later and almost the entire cavity view has returned to view in Figure 5-40 which was taken during the sunlit period of orbit #31. However, the image quality improvement was short lived and by the 34th orbit new material had deposited and almost completely blocked the view through the borescope as shown in Figure 5-41. The image quality continued to change through the remaining test simulation orbits but never improved much beyond that shown in Figure 5-38.

Figure 5-40: Return of Good Cavity Field of View Through the Borescope; Sunlit Period of Orbit #31.

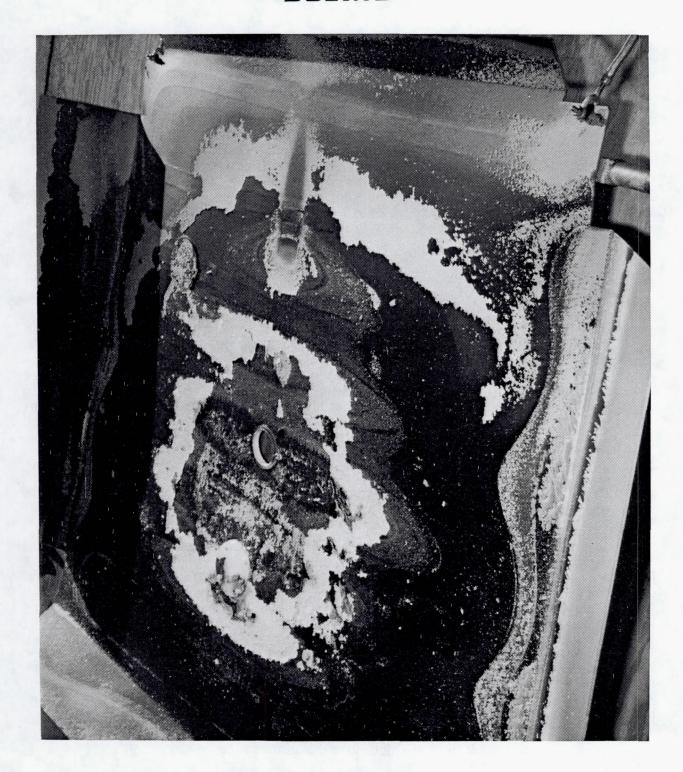
Figure 7-1: Contamination Collected on Cold Plate Surface During Testing.

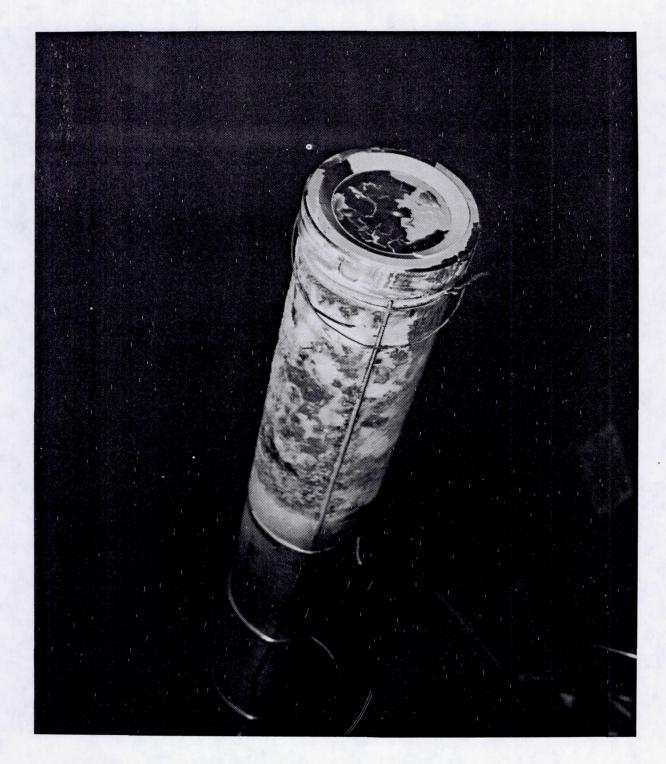
Figure 7-2: Contamination Collected on Borescope Lens During Testing.

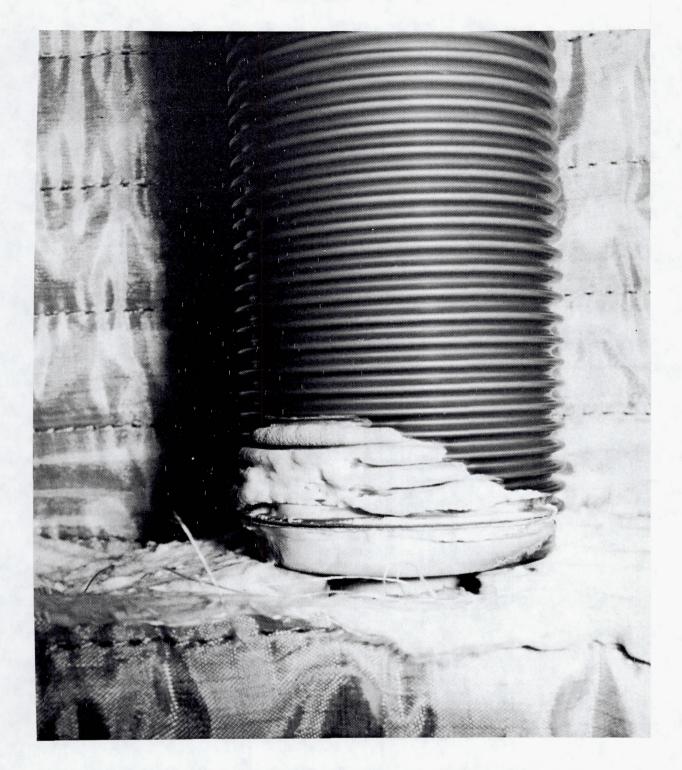
Post-test inspections of the receiver showed 10 of the 24 receiver heat storage tubes had ruptured and leaked small amounts of salt into the receiver cavity. This no doubt caused the corona electrical problems which ended the test conduct. The most significant ruptures all occurred at the inlet end of the corrugated TES containment tubes on the peak of the 1st convolution. In addition, all of the cracks center on the low, gravity side of the tube implying that the failure is probably a result of localized expansion of salt that collects inside the bottom convolutions in this stiff region of the bellows. It is believed that most or all of these ruptures occurred during the cold soak start up test mode because during normal cycling, the salt in this region of the tube remains frozen. It should be noted that no stress analyses were performed on the receiver for this highly transient condition because no cold start up requirement existed when the SDHRT heat receiver was designed. Funding limitations prevented post-test data and failure mode analyses from being performed under the ADRT contract. Although this issue remains unresolved as of this writing, NASA-LeRC will perform metallographic inspections of a convolution crack to determine a plausible failure mode explanation. NASA-LeRC will also remove several heat storage tubes and inspect the condition of the felt metal and the distribution of the salt using computed tomography and mechanical sectioning of the salt annulus.

Figure 7-6: Crack At the Peak of the First Convolution at the Inlet End of Heat Storage Tube #3.

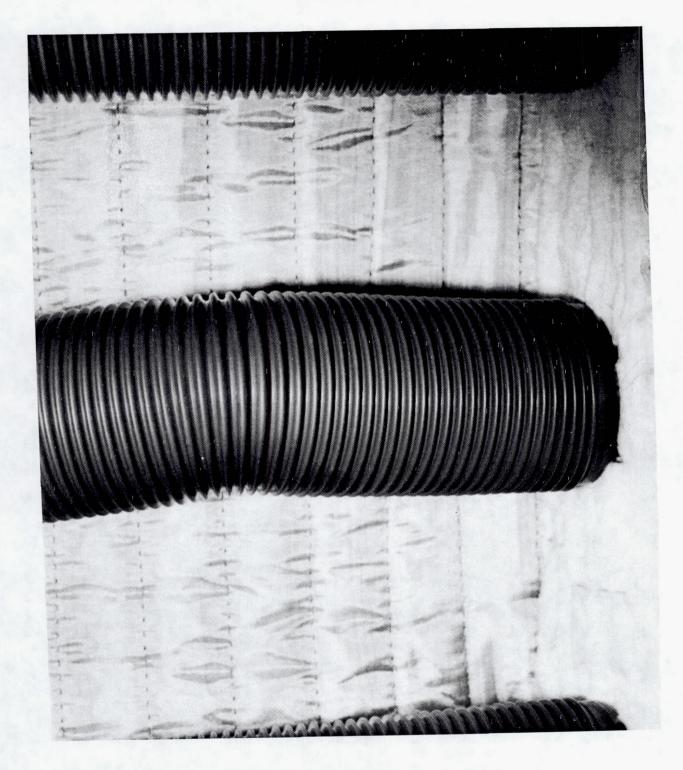
Figure 7-7: Buckled Felt Metal Kink Near the Inlet End of Heat Storage Tube #1.
